Town of Arlington, Massachusetts

PART A – Executive Summary Self- Evaluation and Transition Plan

November 2019

Part A – Executive Summary

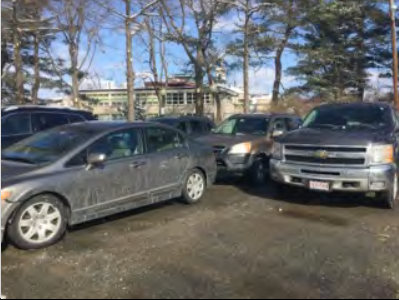
Total # of parking Total # of designated accessible parking spaces Total # of designated van accessible spaces	21 0 0	Provide one van-accessible space. (Cost for leveling, striping and signage.)	1	925	\$925
18	Toilet Room, First Floor	1		Overall Access	Toilet Room

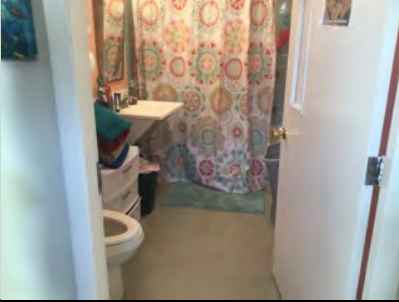
Turning space not provided Accessible plumbing fixtures or stalls not provided	- -	Add an accessible single-user toilet room to this level.	1	12302	\$12302
19	Toilet Room, First Floor	1		Doors, Doorways, & Gates	Toilet Room

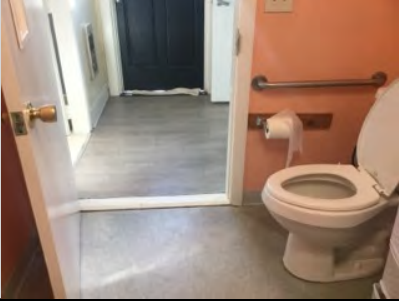
Hardware not operable with a closed fist		Provide hardware that can be operable with one hand and not require tight grasping, pinching, or twisting of the wrist.	1	242	\$242

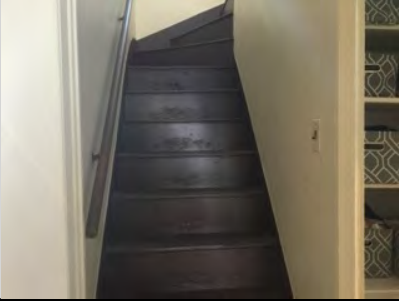
20	Back Staircase	1 2 3		Interior Access Route	N/A

Accessible route not provided	-	No accessible route provided to the second and third floor. If these floors will be used for Town of Arlington programs, a means of accessible vertical circulation should be provided.	1	-	\$0

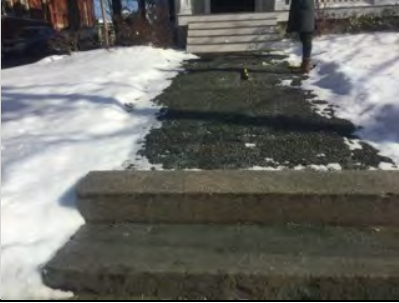
ID	Location	Floor	Room	Element	Type	Photo	Issues	Current Measure	Recommendations	Quantity	Price	Cost Estimation
21	Front Entrance	Ext.		Entrance	Main Entrance

Entrance not on an accessible route Directional sign to accessible entrance not provided		Provide a directional sign indicating the location of the nearest accessible entrance. Where a directional sign is required, it should be located to minimize backtracking. In some cases, this could mean locating a sign at the beginning of a route, not just at the inaccessible entrances to a building.	1	173	\$173

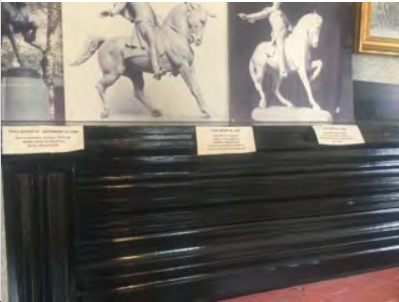
ID	Location	Floor	Room	Element	Type	Photo	Issues	Current Measure	Recommendations	Quantity	Price	Cost Estimation
Best Practice												
1	Throughout the Building	1		N/A	N/A

Best Practice: Consider making the exhibit signage more legible and easier to read. Recommendations for exhibit signage is provided here: https://www.si.edu/Accessibility/SGAED	-	0	\$0
Access to Goods and Services												
2	Massachusetts Avenue Entrance	1	01	Means of Egress	N/A

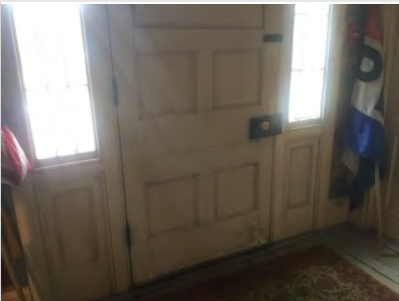
Tactile exit sign not provided Directional sign to accessible emergency exit not provided	-	Provide a directional sign indicating the location of the nearest emergency exit. Ensure tactile exit signs with raised characters and braille are provided at exit doors. Mount signs between 48"- 60" above finished floor located on the latch side of the door.	1	116	\$116
Access to Goods and Services												
3	Native American Room	1	101	Doors, Doorways, & Gates	Circulation

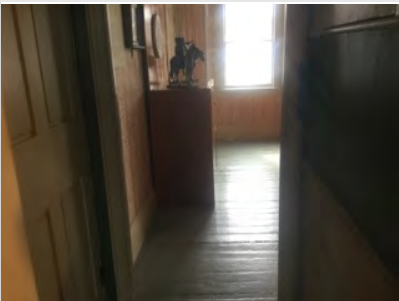
Clear width at door < 32"	30.5"	Alteration may not be feasible. Compliance with the requirements may threaten or destroy the historic significance of the building. Provide a video of the rooms or photographs to provide program accessibility.	1	-	\$0

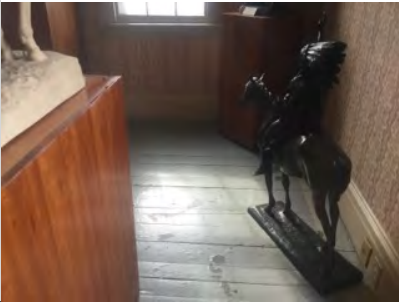
4	Native American Room	1	101	Interior Access Route	N/A

Route < 36" wide	23"	Ensure that a clear width of 36" min. is maintained at the accessible route. Relocate the statue. The route is allowed to narrow to a min. of 32" for 24" max. of depth.	1	Labor	\$0

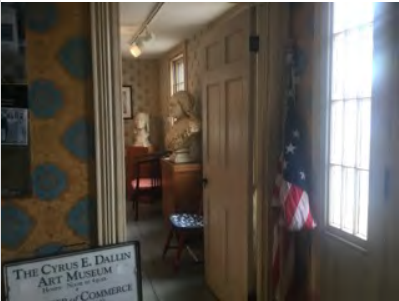
ID	Location	Floor	Room	Element	Type	Photo	Issues	Current Measure	Recommendations	Quantity	Price	Cost Estimation
Access to Goods and Services												
5	History and Ideology Room	1	103	Doors, Doorways, & Gates	Circulation

Clear width at door < 32"	29.75"	Although a swing-clear/offset hinge most likely will not make the door 32" clear, consider adding the hinge to increase clear width, and keep the historic hinge in storage. Provide a video of the rooms or photographs to provide program accessibility.	1	1116	\$1116
6	History and Ideology Room	1	103	Doors, Doorways, & Gates	Circulation

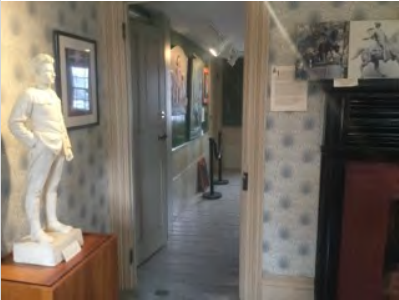
Clear width at door < 32"	31"	Alteration may not be feasible. Compliance with the requirements may threaten or destroy the historic significance of the building. Provide a video of the rooms or photographs to provide program accessibility.	1	-	\$0
Access to Goods and Services												
7	History and Ideology Room	1	104	Interior Access Route	N/A

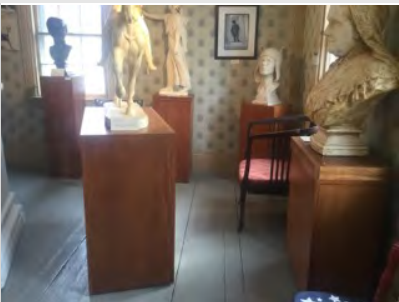
Route < 36" wide	29.75"	Ensure that a clear width of 36" min. is maintained at the accessible route. The route is allowed to narrow to a min. of 32" for 24" max. of depth.	1	Labor	\$0

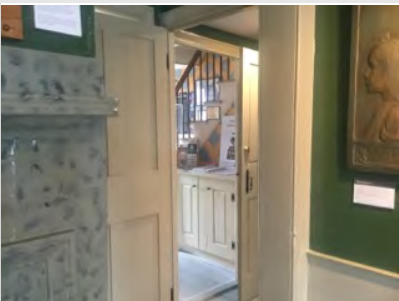
Access to Goods and Services												
8	Northeast Room	1	104	Doors, Doorways, & Gates	Circulation

Clear width at door < 32"	28.5"	Although a swing-clear/offset hinge most likely will not make the door 32" clear, consider adding the hinge to increase clear width, and keep the historic hinge in storage. Provide a video of the rooms or photographs to provide program accessibility.	1	1116	\$1116
9	Northeast Room	1	104	Doors, Doorways, & Gates	Circulation

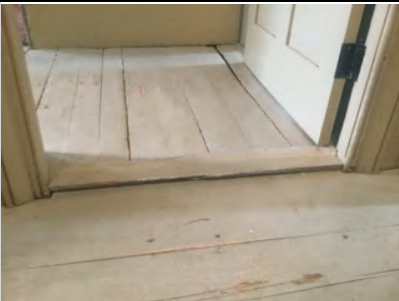
Threshold not beveled Threshold > 1/2" high	- 1"	Alteration may not be feasible. Compliance with the requirements may threaten or destroy the historic significance of the building. Provide a video of the rooms or photographs to provide program accessibility.	1	-	\$0

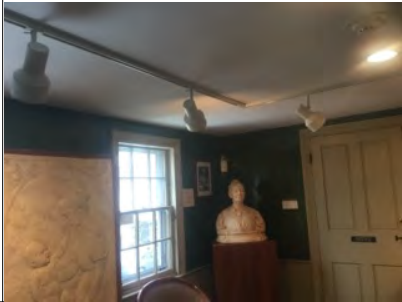
ID	Location	Floor	Room	Element	Type	Photo	Issues	Current Measure	Recommendations	Quantity	Price	Cost Estimation
Access to Goods and Services												
10	Northeast Room	1	104	Interior Access Route	N/A

Obstructed by protruding objects	74"	Provide new lights that are not lower than 80" above finished floor.	1	Labor	\$0
Access to Goods and Services												
11	Upstairs Hallway	1	105	Interior Access Route	N/A

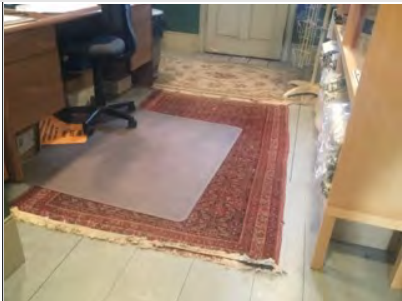
Surface not stable, firm, and slip-resistant	-	Secure the rug.	1	Labor	\$0
12	Upstairs Hallway	1	105	Operable Parts	Other

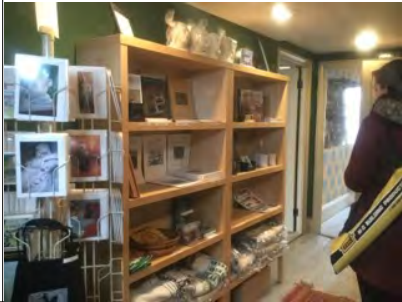
Reach < 15" or > 48"(forward/side approach)	70"	Relocate purchasable items between 15"- 48" above finished floor or provide assistance to visitors.	1	Labor	\$0
Access to Goods and Services												
13	Northwest Room	1	106	Interior Access Route	N/A

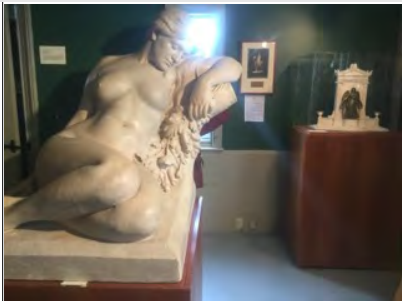
Obstructed by protruding objects	9.5"	Add a cane-detectable barrier rail where sculpture projects into the circulation route.	1	153	\$153

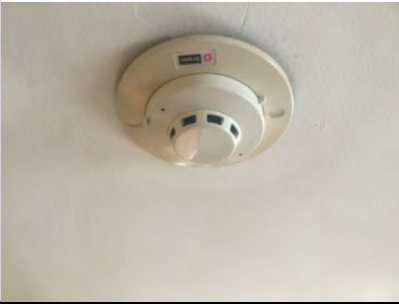
ID	Location	Floor	Room	Element	Type	Photo	Issues	Current Measure	Recommendations	Quantity	Price	Cost Estimation
Additional Access												
14	Throughout the Building	1 B		Fire Alarms	N/A

No visible fire alarm provided within room		When fire system is updated, ensure that a visible fire alarm is installed in each room.	6	330	\$1980
Access to Goods and Services												
15	Stairway	1-B		Interior Access Route	N/A

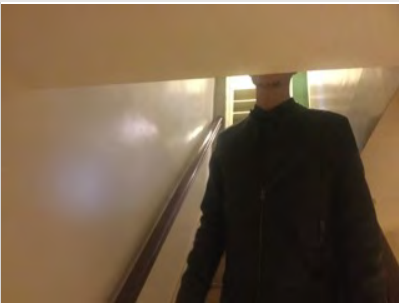
Minimum vertical clearance at 80" minimum not provided	64"	Providing the 80" high vertical clearance minimum may be technically infeasible. Consider adding signage that says, "Low Headroom" or, "Low Ceiling".	1	116	\$116
Best Practice												
16	Stairway	1-B

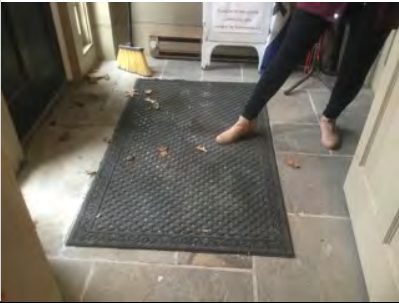
Consider providing signage at the stair directing visitors to the accessible route outside of the building.	1		\$0
Access to Goods and Services												
17	Lower Level Entrance/ Exit	B	01	Doors, Doorways, & Gates	Vestibule

Mat not securely attached	-	Secure the mat.	1	Labor	\$0

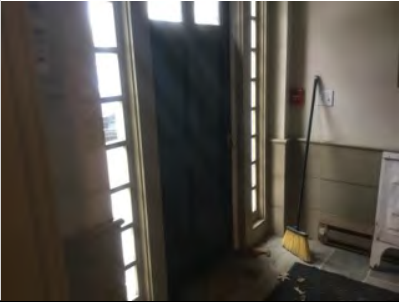
ID	Location	Floor	Room	Element	Type	Photo	Issues	Current Measure	Recommendations	Quantity	Price	Cost Estimation
18	Lower Level Entrance/ Exit	B	01	Means of Egress	N/A

Tactile exit sign not provided		Ensure tactile exit signs with raised characters and braille are provided at exit doors. Mount signs between 48"- 60" above finished floor located on the latch side of the door.	1	116	\$116
Access to Goods and Services												
19	Lower Gallery	B	02	Dining or Work Surfaces	Work Surface

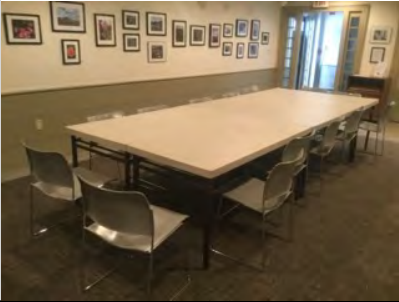
Knee or toe clearance not provided	26.5"	Provide at least 1 work surface with 27" min. knee and toe clearance.	1	350	\$350
20	Lower Gallery	B	02	Interior Access Route	N/A

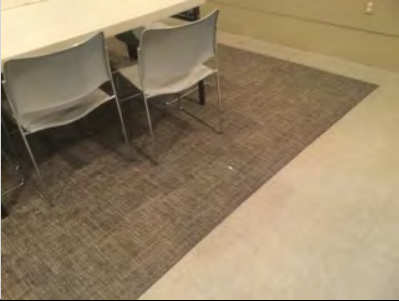
Mat not securely attached	-	Secure the carpet.	1	Labor	\$0
Access to Goods and Services												
21	Route to Lower Gallery	B	06	Interior Access Route	N/A

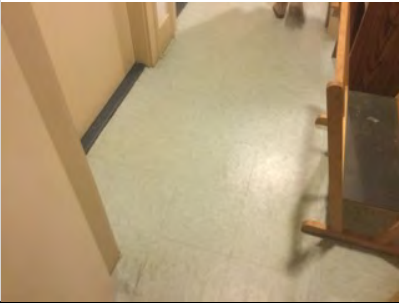
Route < 36" wide	27.25"	Ensure that a clear width of 36" min. is maintained at the accessible route. Relocate the furniture. The route is allowed to narrow to a min. of 32" for 24" max. of depth.	1	Labor	\$0

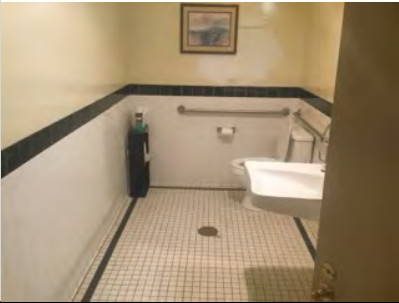
Toilet & Bathing Rooms												
22	Toilet Room 1	B	07	Overall Access	Toilet Room

Audible and visible alarms not provided	-	When fire system is updated, ensure that a visible and audible fire alarm is installed.	1	346	\$346

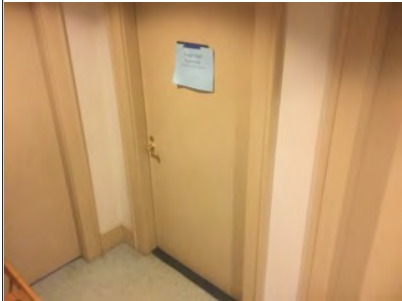
ID	Location	Floor	Room	Element	Type	Photo	Issues	Current Measure	Recommendations	Quantity	Price	Cost Estimation
Access to Goods and Services												
23	Toilet Rooms in Basement	B	07	Doors, Doorways, & Gates	Toilet Room

Door requires > 5 lbs. of force to open	15 lbs	Adjust closers so doors do not require more than 5 pounds of force to open.	2	Labor	\$0
Access to Goods and Services												
24	Toilet Rooms	B	07 08	Signage	Designation

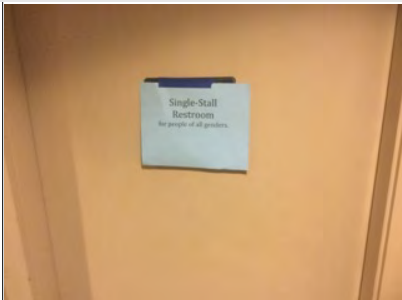
Not provided	-	Locate signage with raised text duplicated in braille alongside the door on the latch side. Provide a sign with the International Sign of Accessibility at the toilet room (08) that is brought into compliance.	2	116	\$232
Toilet & Bathing Rooms												
25	Toilet Room 2	B	08	Overall Access	Toilet Room

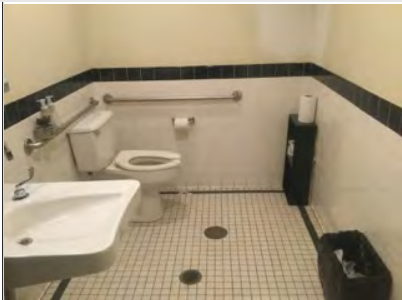
Audible and visible alarms not provided	-	When fire system is updated, ensure that a visible and audible fire alarm is installed.	1	346	\$346

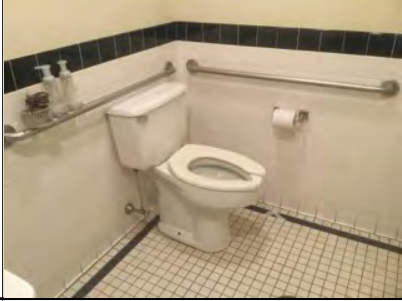
26	Toilet Room 2	B	08	Single-User Toilet	N/A

Centerline < or > 18" (MAAB)	17.5"	Centerline is not entirely compliant but is usable. It complies with ADA 2010 Standards but is half an inch off of Massachusetts 521 CMR.	1	0	\$0
27	Toilet Room 2	B	08	Lavatory	N/A

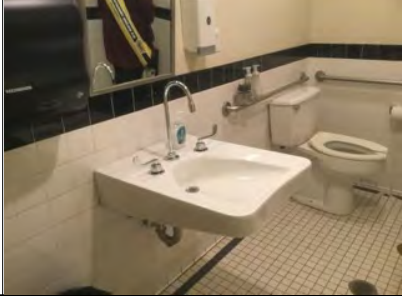
Plumbing underneath is exposed Mirror above lavatory w/reflective surface > 40"	- 44"	Insulate or otherwise configure pipes to prevent contact, for at least one lavatory. Lower mirror so that the bottom surface is at 40" max. above finished floor.	1	174	\$174

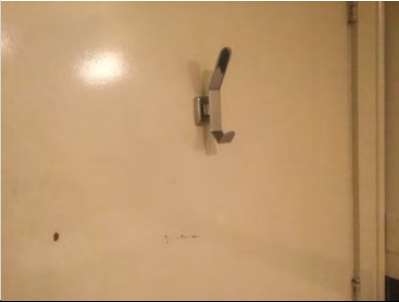
ID	Location	Floor	Room	Element	Type	Photo	Issues	Current Measure	Recommendations	Quantity	Price	Cost Estimation
28	Toilet Room 2	B	08	Single-User Toilet	N/A

Hook located > 48" high	60"	Locate hook no higher than 48" above the finished floor.	1	75	\$75
Approach and Entrance												
29	Entrance Route From Mystic Street	Ext.		Exterior Access Route	Walkway

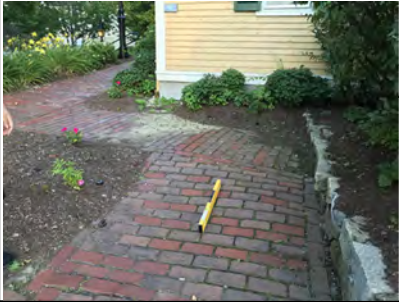
Cross slope > 1:50 (2.00%) Running slope > 1:20 (5%) Surface is not stable, firm, and slip-resistant	3.8% 10.4% -	Renovate the entire brick walkway between the Mystic Street sidewalk and the first floor entrance. Reduce cross slope to be no steeper than 1:50 (2.00%). Reduce running slope to be no steeper than 1:20 (5%). (Cost estimate for leveling and relaying 50 ft. of brick.)	1	3500	\$3500
Access to Goods and Services												
30	Entrance Route From Mystic Street (Sign to Accessible Entrance)	Ext.		Signage	Directional

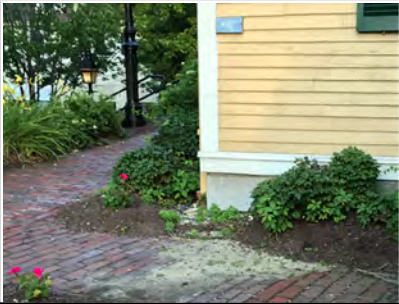
Non glare finish and contrast not provided	-	Provide signs with a non-glare finish with characters that have a high contrast to the background.	1	173	\$173

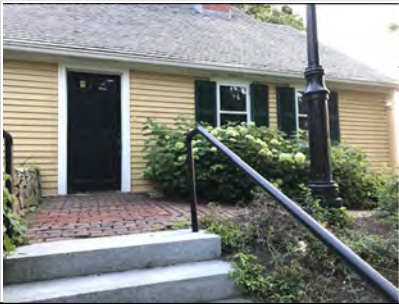
Approach and Entrance												
31	First Floor Entrance Facing Parking Lot	Ext.		Entrance	Main Entrance

International Symbol of Accessibility not provided Maneuvering clearance at door > 1:50 (2.00%)	- 9.8%	Provide the International Symbol of Accessibility. Provide an automatic door opener at an area where the surface is sloped no greater than 1:50 (2.00%). If possible, consider renovating slope at the entrance.	1	1703	\$1703
32	First Floor Entrance Facing Parking Lot	Ext.		Entrance	Main Entrance

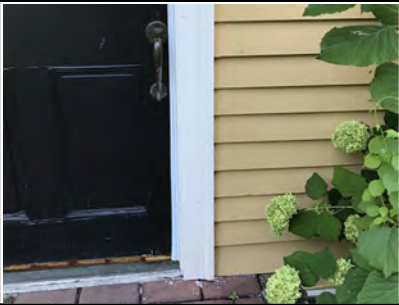
Hardware not operable with a closed fist		Provide hardware that can be operable with one hand and not require tight grasping, pinching, or twisting of the wrist.	1	242	\$242

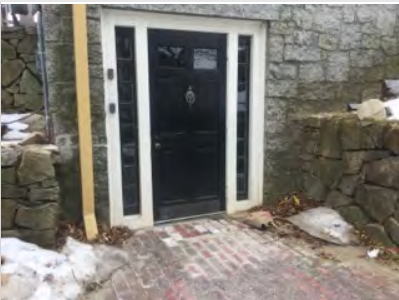
Inclusive Design: Provide a clear floor space of 36" wide min. by 48" deep min. so that a wheelchair user can sit alongside a person seated on the bench.	1		\$0
Approach and Entrance												
34	Lower Level Entrance	Ext.		Entrance	Main Entrance

International Symbol of Accessibility not provided		Provide the International Symbol of Accessibility.	1	173	\$173
Approach and Entrance												
35	Parking Lot	Ext.		Off-Street Parking Lot or Garage	Visitor

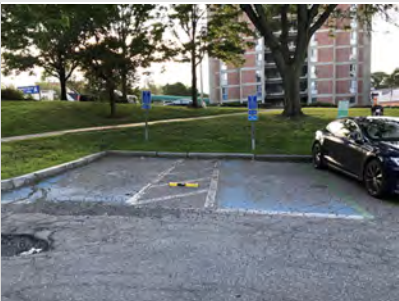
Total # of parking Total # of designated accessible parking spaces Total # of designated van accessible spaces Vehicle space < 96" wide at car space Running or cross slope at space > 1:50 (2.00%) Access aisle < 60" wide at car/van space Sign bottom < 60" above finished grade . Running or cross slope at access aisle > 1:50 (2.00%)	2 2 1 91" 5.2% 51" 5.2% 57"	In the municipal lot by the facility, provide at least one compliant van-accessible space that is at least 96" wide. Provide a marked access aisle that is at least 60" wide. Locate sign with the bottom of the sign 60" above the ground. Reduce running or cross slope to be no steeper than 1:50 (2.00%). Locate sign with the bottom of the sign 60" above the ground.	1	1452	\$1452

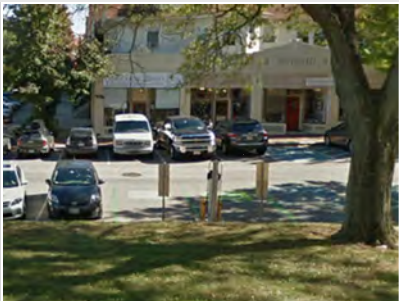
Best Practice												
36	Parking Lot	Ext.

Best Practice: Consider providing a 3' min. access aisle around at least one (1) electric vehicle charging station. Ensure this route connects to the charging port.	1		\$0

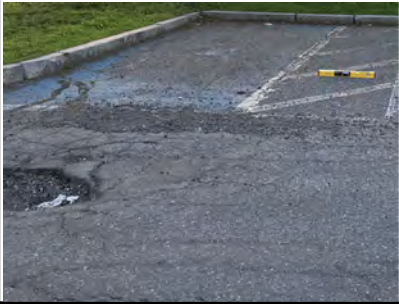
ID	Location	Floor	Room	Element	Type	Photo	Issues	Current Measure	Recommendations	Quantity	Price	Cost Estimation
Approach and Entrance												
37	Parking Lot by Closest Accessible Space	Ext.		Exterior Access Route	Exterior

Level changes > 1/4" . Route not maintained in operable working condition	- -	Renovate the asphalt surface by the accessible parking space that is closest to the facility. (Cost estimate for 5' by 5' asphalt area.)	1	216	\$216
Approach and Entrance												
38	Route Between Parking Lot and Sidewalk (Bottom)	Ext.		Exterior Access Route	Walkway

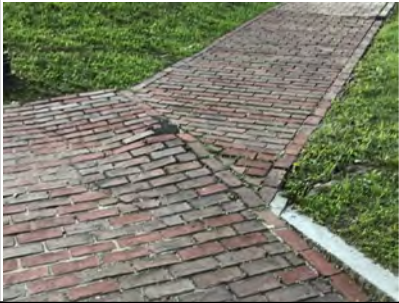
Level changes > 1/4"	-	Remove and re-level bricks by the asphalt area. (Cost estimate for 5' by 5' brick area.)	1	700	\$700
Approach and Entrance												
39	Route Between Parking Lot and Sidewalk (Middle)	Ext.		Exterior Access Route	Walkway

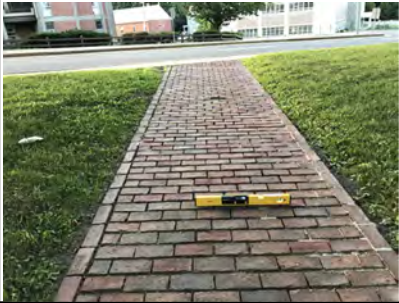
Cross slope > 1:50 (2.00%)	3.9%	Reduce cross slope to be no steeper than 1:50 (2.00%). (Cost estimate for 5' by 5' brick area.)	1	700	\$700

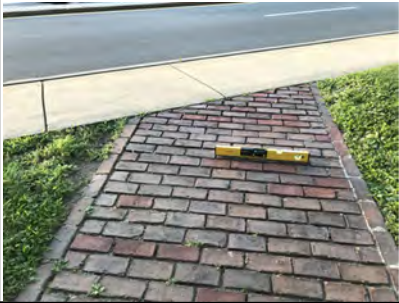
Approach and Entrance												
40	Route Between Parking Lot and Sidewalk (Top)	Ext.		Exterior Access Route	Walkway

Cross slope > 1:50 (2.00%)	6.7%	Reduce cross slope to be no steeper than 1:50 (2.00%). (Cost estimate for 5' by 5' brick area.)	1	700	\$700

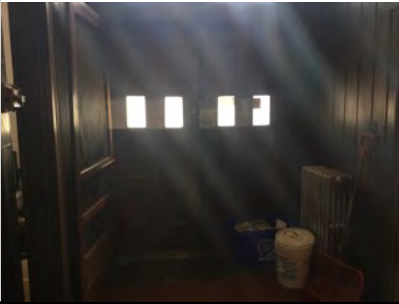
ID	Location	Floor	Room	Element	Type	Photo	Issues	Current Measure	Recommendations	Quantity	Price	Cost Estimation
Approach and Entrance												
1	Cemetery Exit Door	1		Emergency Exit	N/A

Mat not securely attached	-	Ensure the mat is securely attached.	1	Labor	\$0
Access to Goods and Services												
2	Chapel	1		Assembly Area	N/A

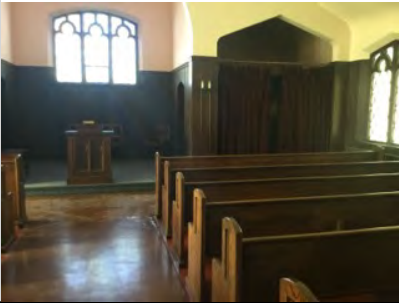
Number of seats Number of designated wheelchair spaces Minimum # wheelchair spaces not provided	92 0 -	Provide four (4) wheelchair spaces that are 36" wide by 60" deep alongside a pew. (Additional cost for design may be needed.)	4	373	\$1492
Access to Goods and Services												
3	Chapel	1		Assembly Area	N/A

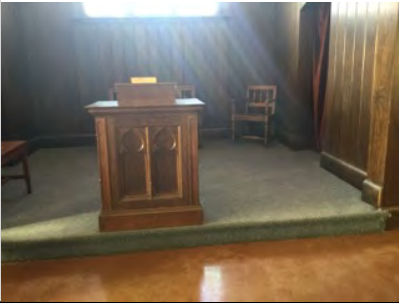
Accessible route to stage not provided	-	Provide a temporary ramp up to the altar that can be put in place when needed. A permanent ramp may obstruct the circulation path and require that the seating layout be rearranged and capacity reduced. (Cost estimate for a 36" wide 7 foot long aluminum ramp without handrails.)	1	570	\$570

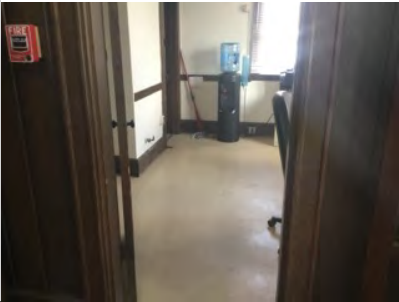
ID	Location	Floor	Room	Element	Type	Photo	Issues	Current Measure	Recommendations	Quantity	Price	Cost Estimation
Access to Goods and Services												
5	Door to Toilet Rooms	1		Doors, Doorways, & Gates	Circulation

Clear width at door < 32" Hardware not operable with a closed fist	31" -	Use offset hinges to widen the door so that there is 32" min. clear width. Provide hardware that can be operable with one hand and not require tight grasping, pinching, or twisting of the wrist.	1	1358	\$1358
Access to Goods and Services												
6	Interior Doorway	1		Doors, Doorways, & Gates	Office

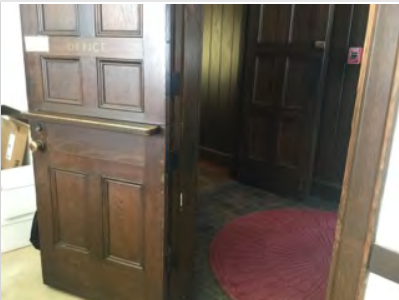
Clear width at door < 32" Hardware not operable with a closed fist	31" -	Use offset hinges to widen the door so that there is 32" min. clear width. Provide hardware that can be operable with one hand and not require tight grasping, pinching, or twisting of the wrist.	1	1358	\$1358
Access to Goods and Services

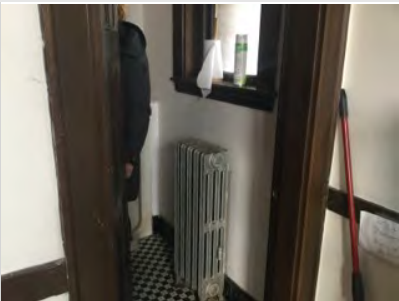
7	Men's and Women's Toilet Rooms	1		Doors, Doorways, & Gates	Toilet Room

Clear width at door < 32" Hardware not operable with a closed fist	27" -	Combine men and women's toilet rooms in order to provide one accessible toilet room. Ensure the door clearance is 32" minimum wide. Provide hardware that can be operable with one hand and not require tight grasping, pinching, or twisting of the wrist. (Cost included in record #8).	1	-	\$0
Toilet & Bathing Rooms												
8	Men's and Women's Toilet Rooms	1		Overall Access	Toilet Room

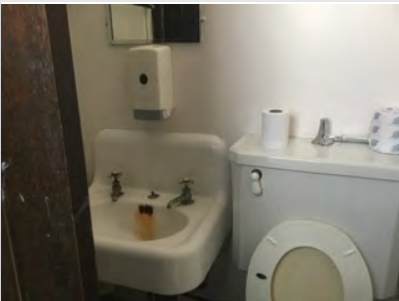
Turning space not provided Accessible plumbing fixtures or stalls not provided	- -	Combine toilet rooms to create an accessible single-user toilet room.	1	12302	\$12302

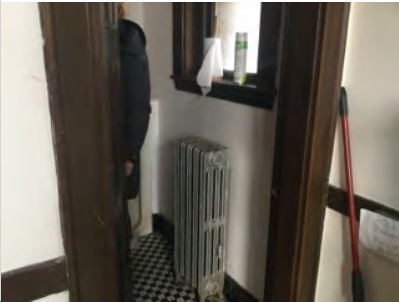
ID	Location	Floor	Room	Element	Type	Photo	Issues	Current Measure	Recommendations	Quantity	Price	Cost Estimation
Access to Goods and Services												
9	Men's/ Women's Toilet Room	1		Signage	Designation

Not provided	-	Locate signage alongside the door on the latch side. Ensure sign has raised characters duplicated in braille.	1	116	\$116
Approach and Entrance												
10	Exterior of Cemetery Building	Ext.		Exterior Access Route	Exterior

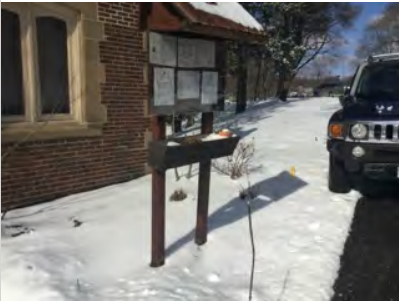
Accessible route not provided	-	Ensure an accessible route is provided to the display case. (Cost estimate is for a 5' x 6' asphalt area in front of display case.)	1	130	\$130
Approach and Entrance												
11	Main Entrance to Cemetery Building	Ext.		Entrance	Main Entrance

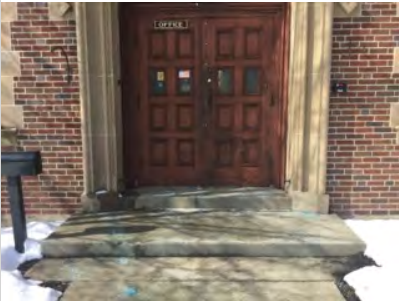
Entrance not on an accessible route	12"	Ensure an accessible route is provided into the Chapel. (Cost estimate is for a concrete dogleg ramp with handrails and three landings.)	1	14032	\$14032

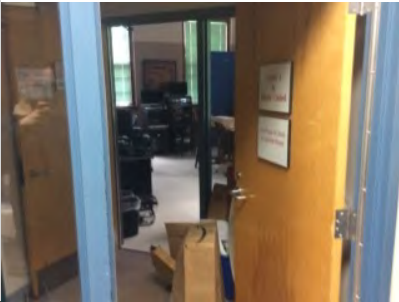
ID	Location	Floor	Room	Element	Type	Photo	Issues	Current Measure	Recommendations	Quantity	Price	Cost Estimation
Access to Goods and Services												
1	Door To Studio A	1	-	Signage	Designation

Raised characters not provided Braille not provided Sign not located on the latch side of the door	- - -	Provide text with raised characters duplicated in braille. Locate sign at permanent rooms alongside the door on the latch side.	1	116	\$116
Access to Goods and Services												
2	Door To Studio A Control Room	1	-	Signage	Designation

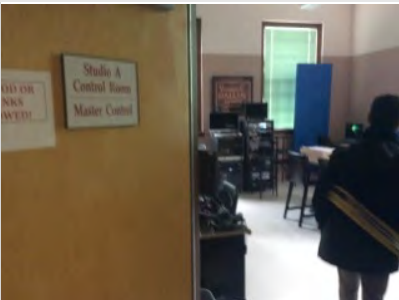
Raised characters not provided Braille not provided Sign not located on the latch side of the door	- - -	Provide text with raised characters duplicated in braille. Locate sign at permanent rooms alongside the door on the latch side.	1	116	\$116
Best Practice												
3	Park Ave Exit (Not in Use as an Entrance)	1	-		Signage

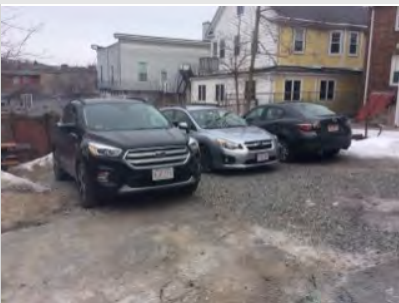
Approach and Entrance												
4	Parking Lot	1	-	Off-Street Parking Lot or Garage	Visitor

Total # of parking Total # of designated accessible parking spaces Total # of designated van accessible spaces	4 0 0	Provide one van accessible space and access aisle. Ensure that the sign has the designation "Van Accessible".	1	925	\$925

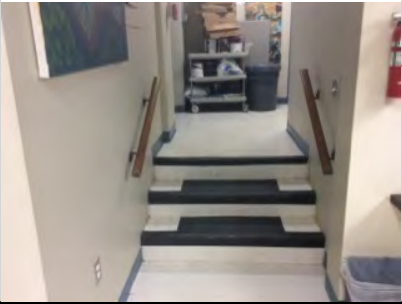
ID	Location	Floor	Room	Element	Type	Photo	Issues	Current Measure	Recommendations	Quantity	Price	Cost Estimation
Access to Goods and Services												
5	Route To Upper Level	1	-	Stairways	Interior

Handrail height < 34" or > 38" Handrails do not extend 12" from stairs	30" -	Alter so the handrails are 34"- 38" high above the floor. Top: Ensure handrails extend horizontally above the landing for 12" min. beginning above the first riser nosing. Bottom: Ensure handrails extend to one tread depth beyond the last riser.	4	Labor 100	\$400
Best Practice												
6	Stairs To Street Level Entrance	1	-		Stairs

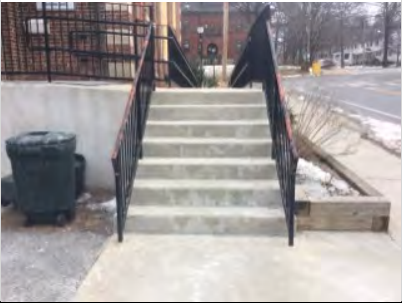
-	Best practice: to increase visibility of stairs, provide a contrast strip on each tread.	1		\$0
Approach and Entrance												
7	Street Level Entrance	1	-	Emergency Exit	N/A

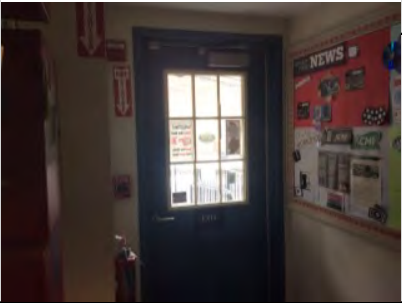
Maneuvering clearance(s) not provided	-	Relocate the fire extinguisher from the latch side of the door so that there is 12 inches of maneuvering clearance alongside the door.	1	Labor	\$0

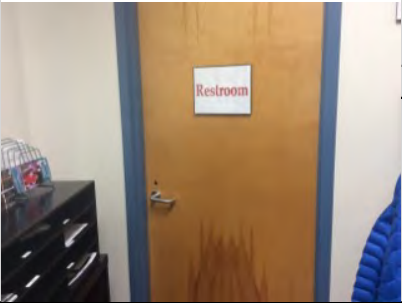
Access to Goods and Services												
8	Toilet Room Near Recording Studio	1	-	Signage	Designation

Raised characters not provided Braille not provided Sign not located on the latch side of the door	- - -	Provide text with raised characters duplicated in braille. Locate sign at permanent rooms alongside the door on the latch side. Relocate the cabinet to provide 18" x 18" of clear floor space in front of the sign.	1	116	\$116

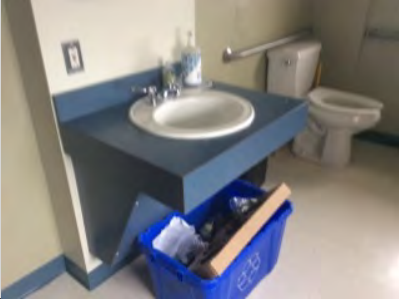
ID	Location	Floor	Room	Element	Type	Photo	Issues	Current Measure	Recommendations	Quantity	Price	Cost Estimation
Toilet & Bathing Rooms												
9	Toilet Room Near Recording Studio	1	-	Lavatory	N/A

Toe or knee clearances not provided Mirror above lavatory w/reflective surface > 40"	- 52"	Relocate the recycling bin from underneath the lavatory. Lower mirror so that the bottom surface is at 40" max. above finish floor.	1	128	\$128
10	Toilet Room Near Recording Studio	1	-	Single-User Toilet	N/A

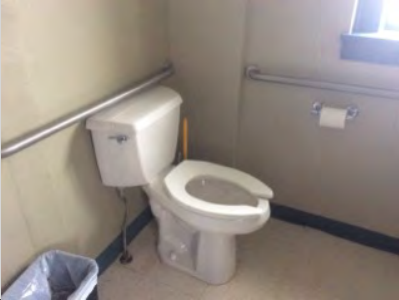
Side grab bar > 12" max. from the rear wall	18"	Provide wood blocking at side grab bar wall to provide a level surface for remounting the grab bar 12" max. from the rear wall. Relocate the side grab bar on the blocking to be no further than 12" max. from the rear wall.	1	453	\$453
11	Toilet Room Near Recording Studio	1	-	Single-User Toilet	N/A

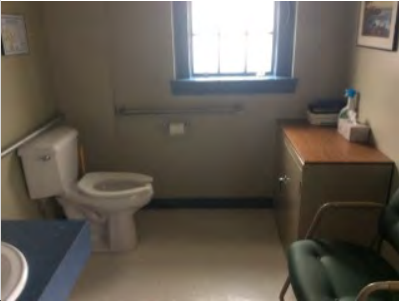
Clearance at toilet < 72" clear depth > 42" clear at the water closet front edge	- 35"	Relocate file cabinet in front of toilet to provide a clear floor space that is 72" deep min. and ensure that there is at least 42" between the front edge of the water closet and the nearest obstruction.	1	Labor	\$0

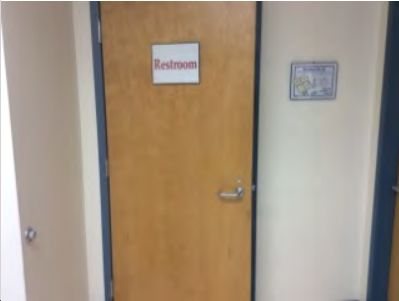
Access to Goods and Services												
12	Basement Toilet Room	B	-	Signage	Designation

Raised characters not provided Braille not provided Sign not located on the latch side of the door	-	Provide text with raised characters duplicated in braille. Locate sign at permanent rooms alongside the door on the latch side.	1	116	\$116
Toilet & Bathing Rooms												
13	Basement Toilet Room	B	-	Overall Access	Toilet Room

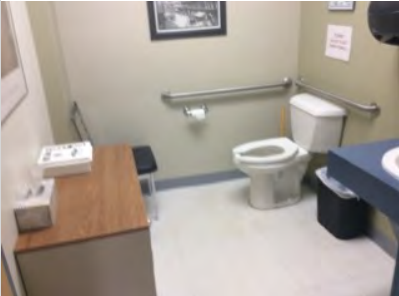
Turning space not provided	35"	Remove interior furnishings in order to ensure turning space is provided in the room.	1	Labor	\$0

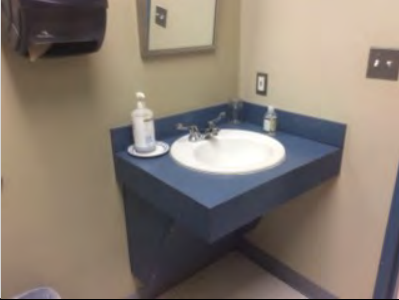
ID	Location	Floor	Room	Element	Type	Photo	Issues	Current Measure	Recommendations	Quantity	Price	Cost Estimation
14	Basement Toilet Room	B	-	Lavatory	N/A

Mirror above lavatory w/reflective surface > 40" Dispensers not within reach range	49" 49"	Lower mirror so that the bottom surface is at 40" max. above finish floor. Relocate paper towel dispenser to 42" max. above the floor.	1	481	\$481
15	Basement Toilet Room	B	-	Single-User Toilet	N/A

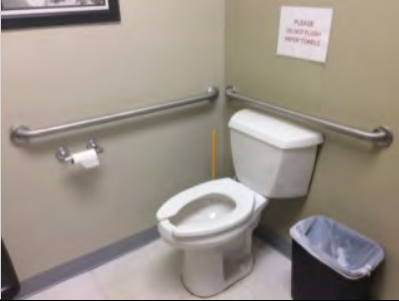
Flush control not on open side	-	Relocate the flush control to the open side.	1	187	\$187
Access to Goods and Services												
16	Conference Room	B	-	Signage	Designation

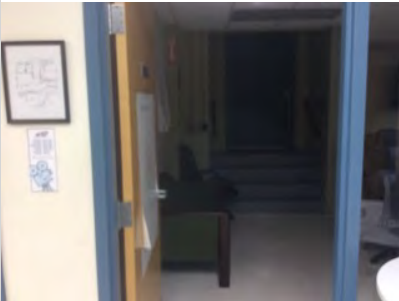
Sign not located on the latch side of the door Braille not provided	-	Provide a sign with braille. Locate sign at permanent rooms alongside the door on the latch side.	1	116	\$116
17	Conference Room	B	-	Means of Egress	N/A

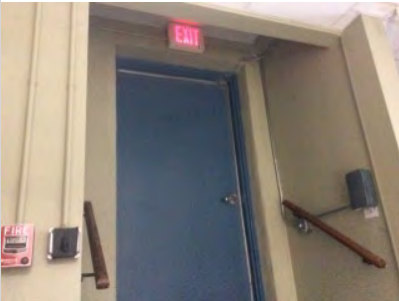
Tactile exit sign not provided Directional sign to accessible emergency exit not provided	-	Provide a directional sign indicating the location of the nearest emergency exit. Ensure tactile exit signs with raised characters and braille are provided at exit doors. Mount signs between 48"- 60" above finish floor located on the latch side of the door.	1	116	\$116

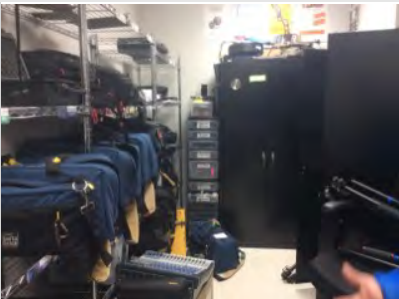
Access to Goods and Services												
18	Equipment Closet	B	-	Operable Parts	Equipment

Clear floor space is not provided Reach < 15" or > 48"(forward/side approach)	- 72"	Relocate stored items so there is a 36" clear route through the space. Relocate film production gear to be between 15"- 48" above finish floor.	1	Labor	\$0

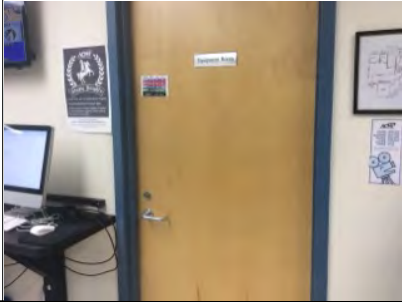
ID	Location	Floor	Room	Element	Type	Photo	Issues	Current Measure	Recommendations	Quantity	Price	Cost Estimation
19	Equipment Closet	B	-	Signage	Designation

Sign not located on the latch side of the door	-	Locate sign at permanent rooms alongside the door on the latch side. Relocate the furniture to provide 18" x 18" of clear floor space in front of the sign.	1	Labor	\$0
Access to Goods and Services												
20	Side Accessible Entrance Near Editing Level	B	-	Means of Egress	N/A

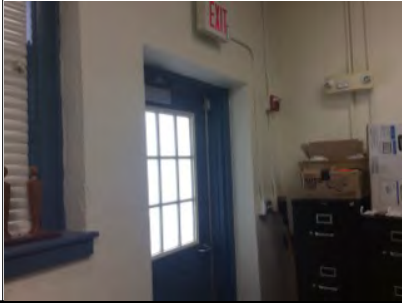
Tactile exit sign not provided	-	Ensure tactile exit signs with raised characters and braille are provided at exit doors. Mount signs between 48"- 60" above finish floor located on the latch side of the door. The cabinet should be relocated to provide 18" x 18" of clear floor space in front of the sign.	1	116	\$116
Access to Goods and Services												
21	Stairwell To Upper Level	B	-	Stairways	Interior

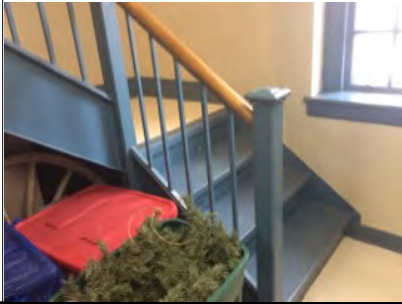
Handrail height < 34" or > 38" Handrail not provided on both sides Handrails do not extend 12" from stairs Handrails not continuous where required	33"	Ensure that at least one compliant handrail is provided on one side. Locate the handrail 34"-38" high above the floor. Top: Ensure handrails extend horizontally above the landing for 12" min. beginning above the first riser nosing. Bottom: Ensure handrails extend to one tread depth beyond the last riser. Ensure that handrail is continuous and returns to a wall, guard, or the landing surface.	1	Labor 1110	\$1110

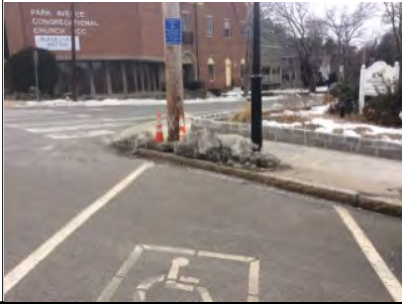
Best Practice												
22	On-Street Parking	Ext.	-		On-Street Parking

Total # of parking Total # of designated accessible parking spaces Running or cross slope at space > 1:50 (2.00%)	5 1 10%	Best practice: Consider renovating the accessible on-street parking space that is provided near the first floor entrance. To improve accessibility, consider reducing the slope to be no steeper than 1:50 (2.00%) at the space. Also consider providing an access aisle that is connected to the curb ramp at the corner.	1		\$0

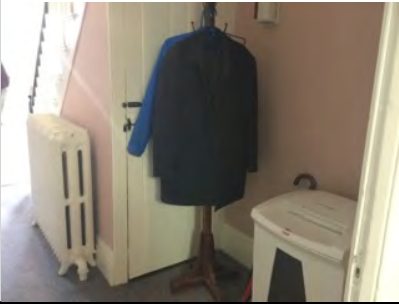
ID	Location	Floor	Room	Element	Type	Photo	Issues	Current Measure	Recommendations	Quantity	Price	Cost Estimation
Access to Goods and Services												
1	Front Hall	1		Operable Parts	Clothes Rod/Hooks

Reach < 15" or > 48"(forward/side approach)	60.5"	Provide an alternate coat rack with hooks 15"-48" above finish floor.	1	Labor	\$0
Approach and Entrance												
2	Main Office	1		Entrance	Other

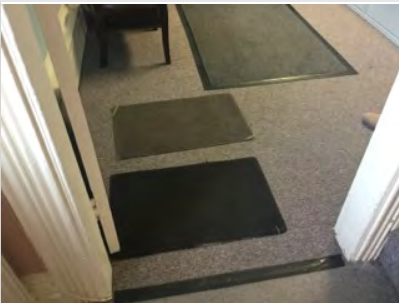
Mat not securely attached	-	Secure the mats.	3	Labor	\$0
Access to Goods and Services												
3	Main Office	1		Doors, Doorways, & Gates	Office

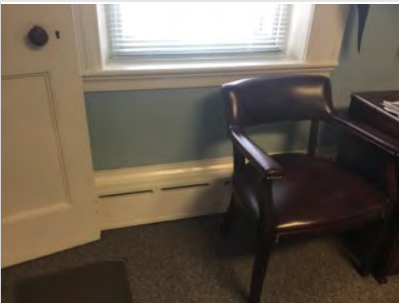
Maneuvering clearance(s) not provided	21"	The chair acts as an obstruction to the door maneuvering clearance, and must be moved to a new location.	1	Labor	\$0
Approach and Entrance												
4	Northwest Emergency Exit	1		Emergency Exit	N/A

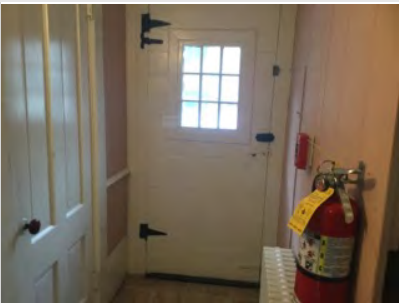
Directional sign to accessible emergency exit not provided Emergency exit not on an accessible route Maneuvering clearance(s) not provided Hardware not operable with a closed fist	- - - -	Provide a directional sign indicating the location of the nearest emergency exit. Exit is not level but hardware should be replaced. Provide hardware that can be operable with one hand and not require tight grasping, pinching, or twisting of the wrist.	1	358	\$358

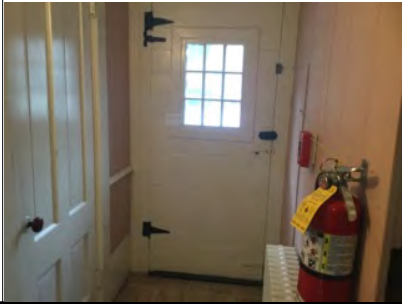
ID	Location	Floor	Room	Element	Type	Photo	Issues	Current Measure	Recommendations	Quantity	Price	Cost Estimation
Access to Goods and Services												
5	Northwest Emergency Exit	1		Means of Egress	N/A

Tactile exit sign not provided	-	Ensure tactile exit signs with raised characters and braille are provided at exit doors. Mount signs between 48"- 60" above finish floor located on the latch side of the door.	1	116	\$116
Access to Goods and Services												
6	Rear Office	1		Interior Access Route	N/A

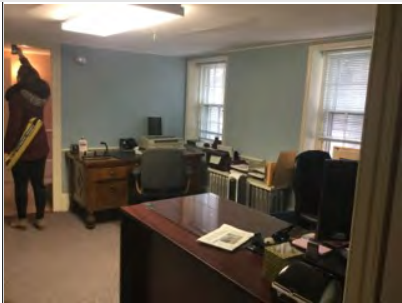
Obstructed by protruding objects	77"	Providing the 80" high minimum might be technically infeasible. Consider adding signage that says, "Low Headroom" or, "Low Ceiling."	1	116	\$116
Access to Goods and Services												
7	Right Front Office	1		Dining or Work Surfaces	Work Surface

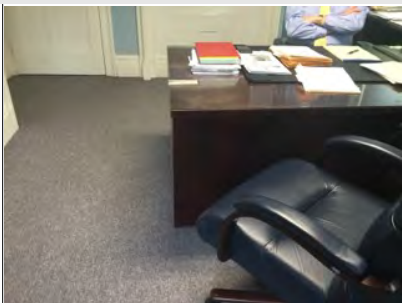
Knee or toe clearance not provided	9"	Provide at least 1 work surface with 27" min. knee and toe clearance on the public side.	1	350	\$350

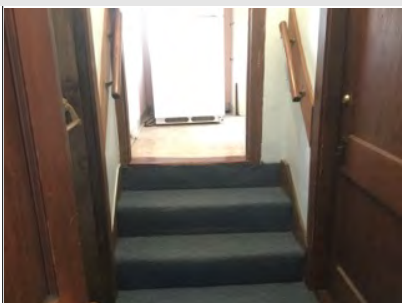
Access to Goods and Services												
8	Route to Conference Room	1		Interior Access Route	N/A

Accessible route not provided		The conference room is not located on an accessible route. Relocate meetings with the public to the accessible portion of the first floor.	1	Policy	\$0

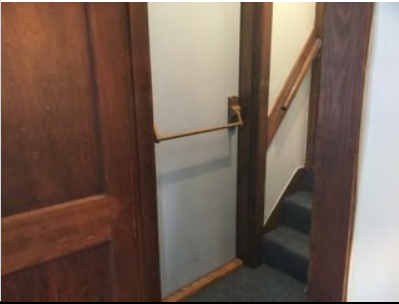
ID	Location	Floor	Room	Element	Type	Photo	Issues	Current Measure	Recommendations	Quantity	Price	Cost Estimation
Approach and Entrance												
9	Southwest Emergency Exit	1		Emergency Exit	N/A

Emergency exit not on an accessible route Directional sign to accessible emergency exit not provided Clear width at door < 32"	<ul style="list-style-type: none">---	Provide a directional sign indicating the location of the nearest emergency exit. Exit is not level but door width should be addressed. Use offset hinges to widen the door so that there is 32" min. clear width.	1	1232	\$1232
Access to Goods and Services												
10	Southwest Emergency Exit	1		Means of Egress	N/A

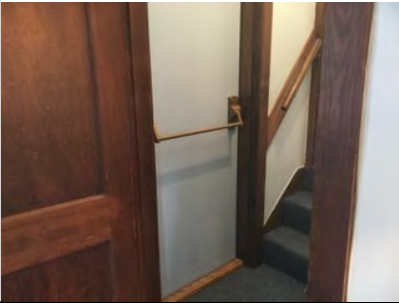
Tactile exit sign not provided	<ul style="list-style-type: none">---	Ensure tactile exit signs with raised characters and braille are provided at exit doors. Mount signs between 48"- 60" above finish floor located on the latch side of the door.	1	116	\$116

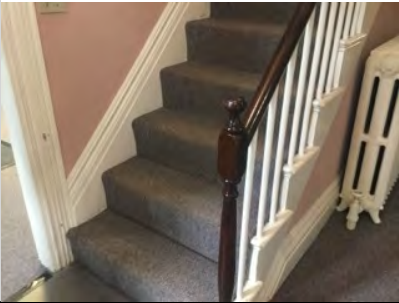
Access to Goods and Services												
11	Stairs to Second Floor	1		Interior Access Route	N/A

Accessible route not provided		The second floor offices are not located on an accessible route. Ensure that staff is able to meet with the public on the first floor.	1	Policy	\$0
Additional Access												
12	Throughout Building	1		Fire Alarms	Office

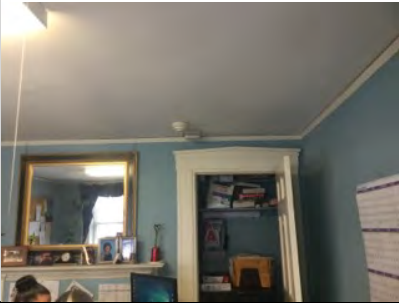
No visible fire alarm provided within room	<ul style="list-style-type: none">--	When fire system is updated, ensure that a visible fire alarm is installed in each room. (Cost for visible alarms.)	8	330	\$2640

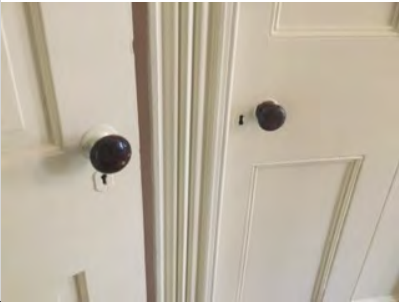
ID	Location	Floor	Room	Element	Type	Photo	Issues	Current Measure	Recommendations	Quantity	Price	Cost Estimation
Access to Goods and Services												
13	Throughout Building	1		Doors, Doorways, & Gates	Circulation

Hardware not operable with a closed fist	-	Provide hardware that can be operable with one hand and not require tight grasping, pinching, or twisting of the wrist. NB: Historic hardware may have additional cost.	10	242	\$2420
14	Throughout Building	1		Doors, Doorways, & Gates	Circulation

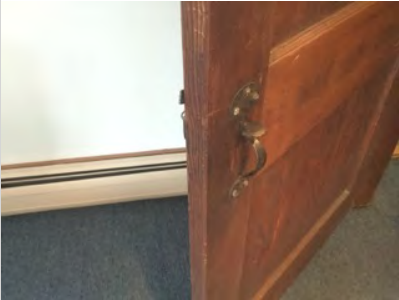
Hardware not operable with a closed fist	-	Provide hardware that can be operable with one hand and not require tight grasping, pinching, or twisting of the wrist. NB: Historic hardware may have additional cost.	4	242	\$968
Access to Goods and Services												
15	Toilet Room	1		Signage	Designation

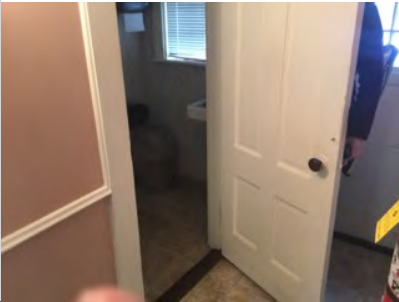
Not provided	-	Locate sign with raised characters and braille alongside the door on the latch side.	1	116	\$116

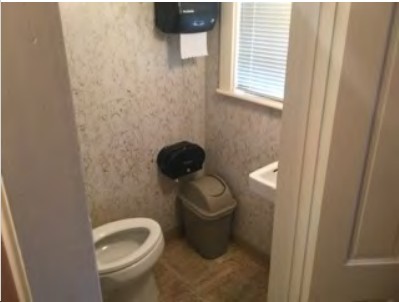
Toilet & Bathing Rooms												
16	Toilet Room	1		Overall Access	Toilet Room

Accessible plumbing fixtures or stalls not provided	-	Add an accessible single-user toilet room.	1	12302	\$12302

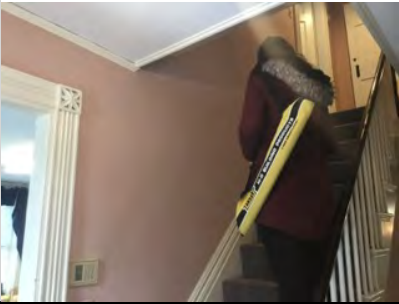
ID	Location	Floor	Room	Element	Type	Photo	Issues	Current Measure	Recommendations	Quantity	Price	Cost Estimation
Access to Goods and Services												
17	Front Stairway	2		Interior Access Route	N/A

Minimum vertical clearance not provided.	69.75"	Providing the 80" high minimum might be technically infeasible. Consider adding signage that says, "Low Headroom" or, "Low Ceiling."	1	116	\$116
Approach and Entrance												
18	Main Entrance	Ext		Entrance	Main Entrance

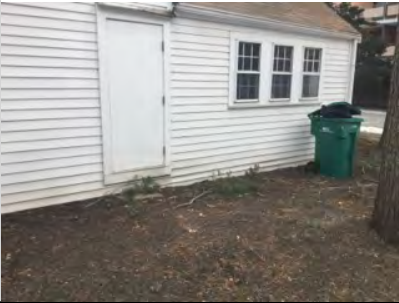
Best Practice												
20	Emergency Exit	Ext.

Consider making an accessible route from this emergency exit. This route could also be used to get the public into the conference room that is located at a lower level than most of the first floor.	1		\$0

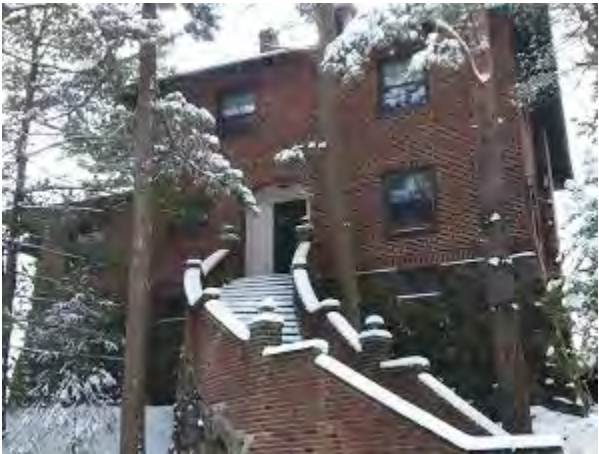
Mount Gilboa House

There are severe accessibility issues with this house including lack of an accessible entrance, lack of an accessible route between floors, doors that lack a 32-inch clear width and lack of accessible toilet rooms. Major renovations will be needed to make this facility accessible and would most likely be technically infeasible. IHCD recommends not locating public programs at this building.

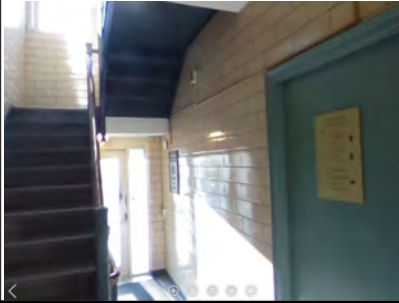
Tactile exit sign not provided		Ensure tactile exit signs with raised characters and braille are provided at exit doors. Mount signs between 48"- 60" above finish floor located on the wall beside the latch side of the door.	2	116	\$232
Access to Goods and Services												
2	Annex, Counter at Entrance of Planning Offices	1		Service Counter	N/A

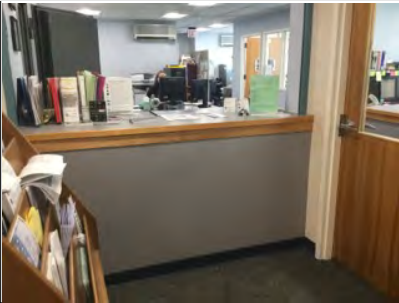
Counter > 36" high	41.5"	Provide a counter that is 36" max. above the ground or finished floor.	1	440	\$440
Additional Access												
3	Annex, Near Planning Offices	1		Drinking Fountains	Low

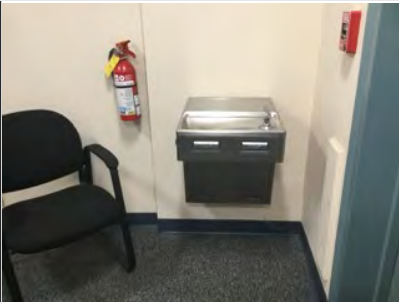
No drinking fountain provided for standing users Operable parts malfunctioning	- -	Provide an additional drinking fountain for standing users or install a hi-lo drinking fountain. Repair or replace drinking fountain to ensure operable parts can be operable with one hand and not require tight grasping, pinching, or twisting of the wrist.	1	2014	\$2014

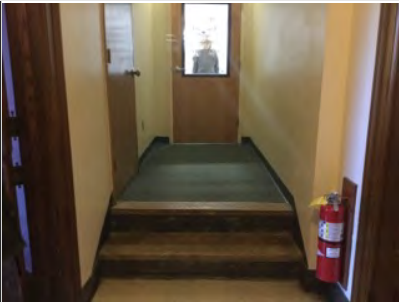
Best Practice												
4	Annex, Planning and Community Development Inaccessible Route	1

-	Stair: Consider providing at least one handrail.	1		\$0

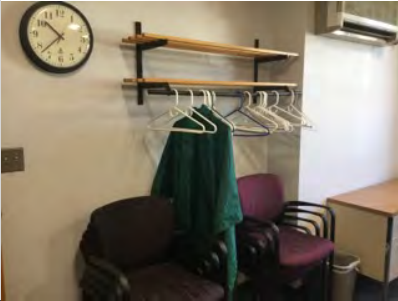
Reach < 15" or > 48"(forward/side approach)	60"	Relocate the coat rack to be 48" max. above finished floor.	1	128	\$128
Access to Goods and Services												
6	Annex, Planning Office	1		Operable Parts	Clothes Rod/Hooks

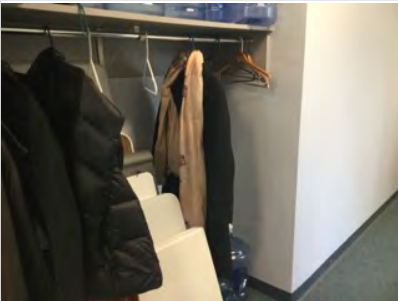
Reach < 15" or > 48"(forward/side approach)	61.25"	Relocate the coat rack to be 48" max. above finished floor.	1	128	\$128
Approach and Entrance												
7	Annex, Route to Accessible Entrance	1		Exterior Access Route	Walkway

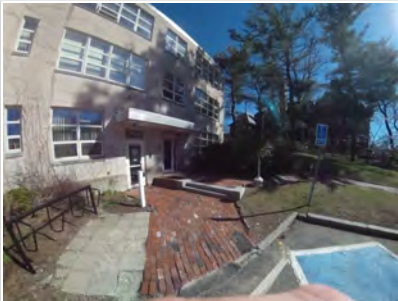
Surface openings > 1/2" Route not maintained in operable working condition	.75" -	Patch the section where brick meets asphalt so that there are no openings greater than 1/2" or bumps. Repair and maintain brick route to accessible entrance to ensure that there are no changes in level greater than 1/4" and no openings wider than 1/2". (Cost estimate based on installation for a 15' long concrete route.)	1	345	\$345

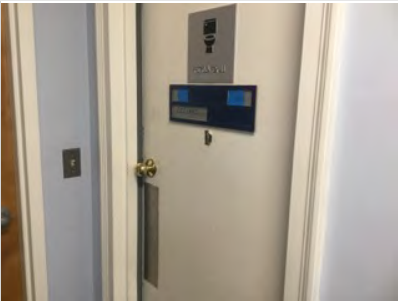
Access to Goods and Services												
8	Annex, Toilet Room in Planning Offices	1		Doors, Doorways, & Gates	Toilet Room

Clear width at door < 32" Hardware not operable with a closed fist Door requires > 5 lbs. of force to open	31" - 15 lbs.	Use offset hinges to ensure that there is 32" minimum clear at the door. Provide hardware that can be operable with one hand and not require tight grasping, pinching, or twisting of the wrist. Adjust closers so doors do not require more than 5 pounds of force to open.	1	1358 Labor	\$1358
9	Annex, Toilet Room in Planning Offices	1		Doors, Doorways, & Gates	Toilet Room

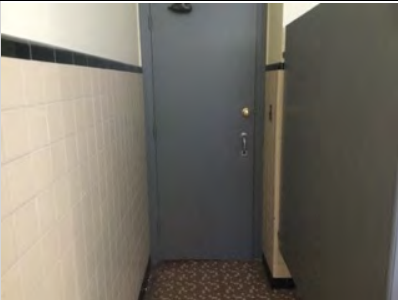
Maneuvering clearance(s) not provided	-	Provide an automatic door opener.	1	1530	\$1530

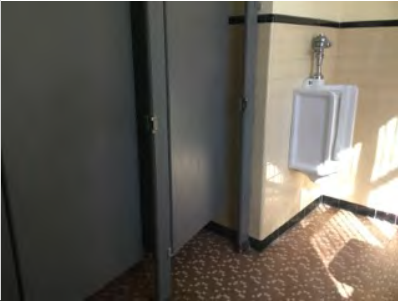
Accessible plumbing fixtures or stalls not provided	-	Provide one accessible wheelchair stall.	1	3091	\$3091
11	Annex, Toilet Room in Planning Offices	1		Lavatory	N/A
